**ATTACHMENT I**  
**SOIL INSPECTION/SAMPLING PLAN**  
**FOR ROADS/PARKING LOTS**

Original: August 22, 2005  
Revision 1: January 31, 2006

**Proposed NOA Sampling Locations**  
Hitachi GST  
San Jose, California

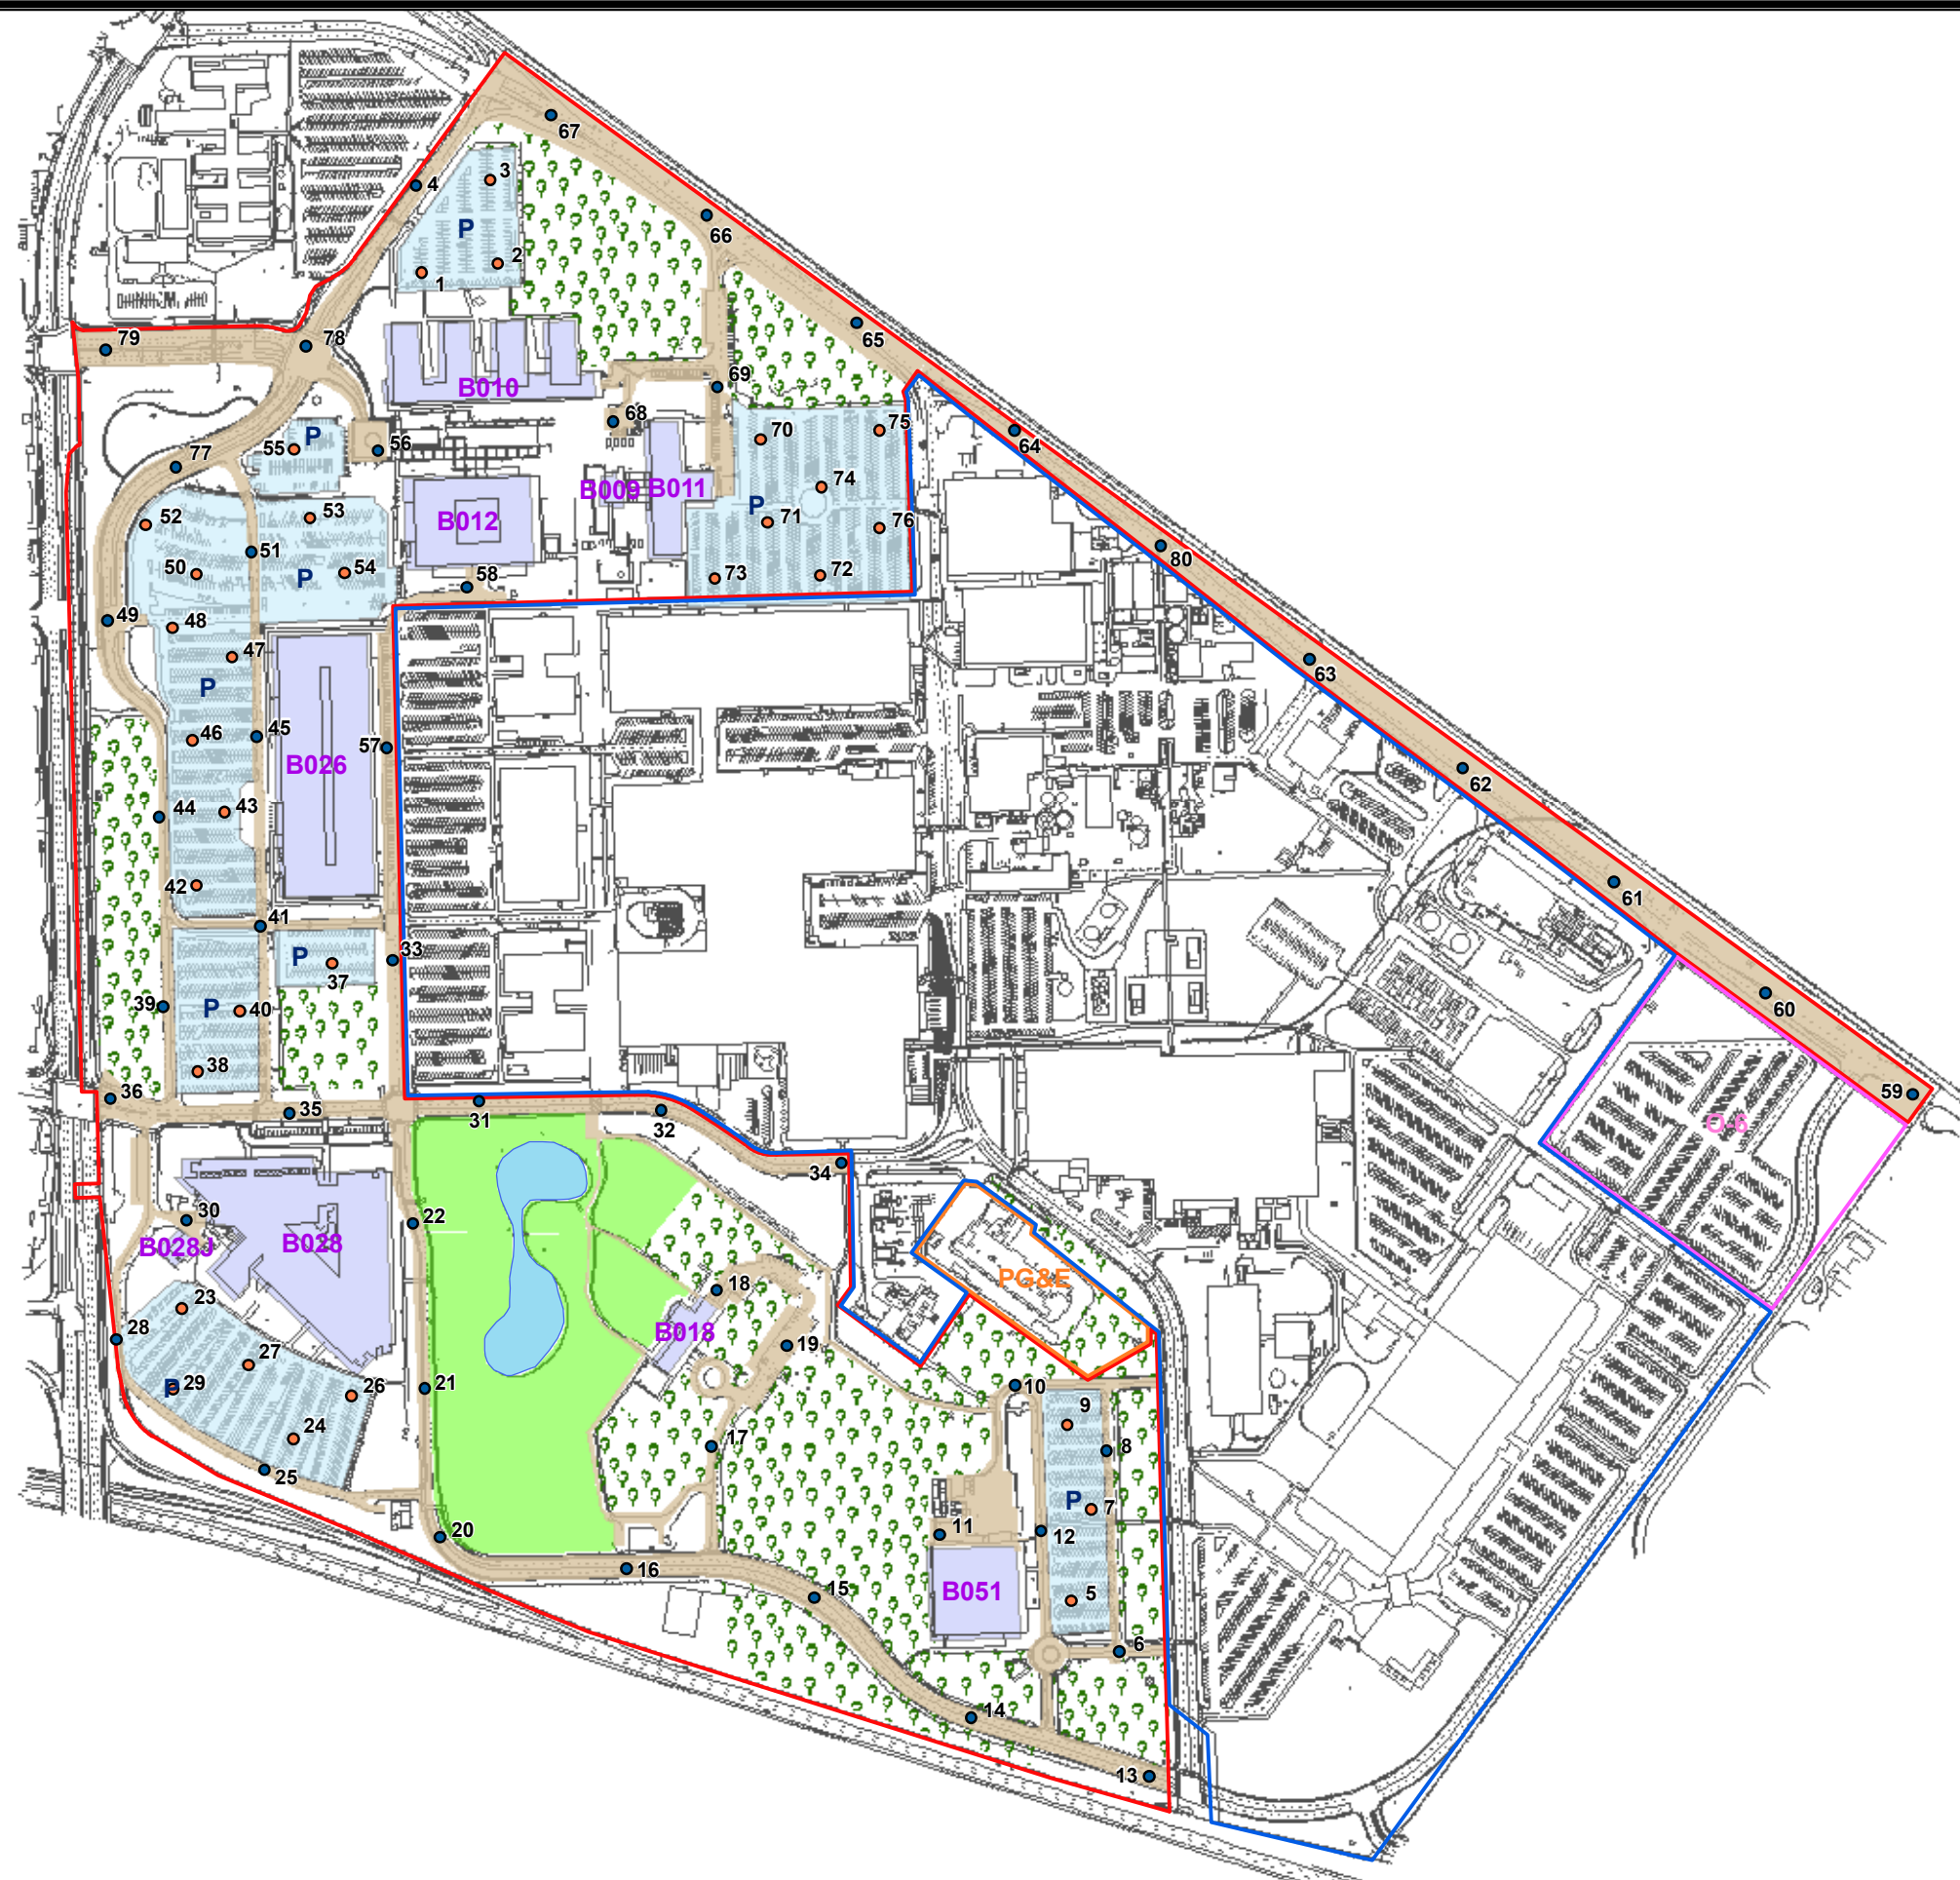
All roadways and parking areas in the Redevelopment Area are highlighted on Figure I.1. In addition, Endicott Boulevard/Tucson Way has been highlighted.

Three samples per acre will be collected from the aggregate fill beneath the asphalt parking lots for analysis of asbestos. The samples will be composited by the laboratory such that one, three-point composite sample will be analyzed per acre of parking lot. Similarly, one three-point composite sample will be analyzed for every 500 feet of roadway. It is anticipated that a total of approximately 85, three-point composite samples will be analyzed for asbestos from the aggregate fill beneath the roadways and parking lots. The proposed three-point composite sampling locations are summarized on Table I.1 and are also depicted on Figure I.1.

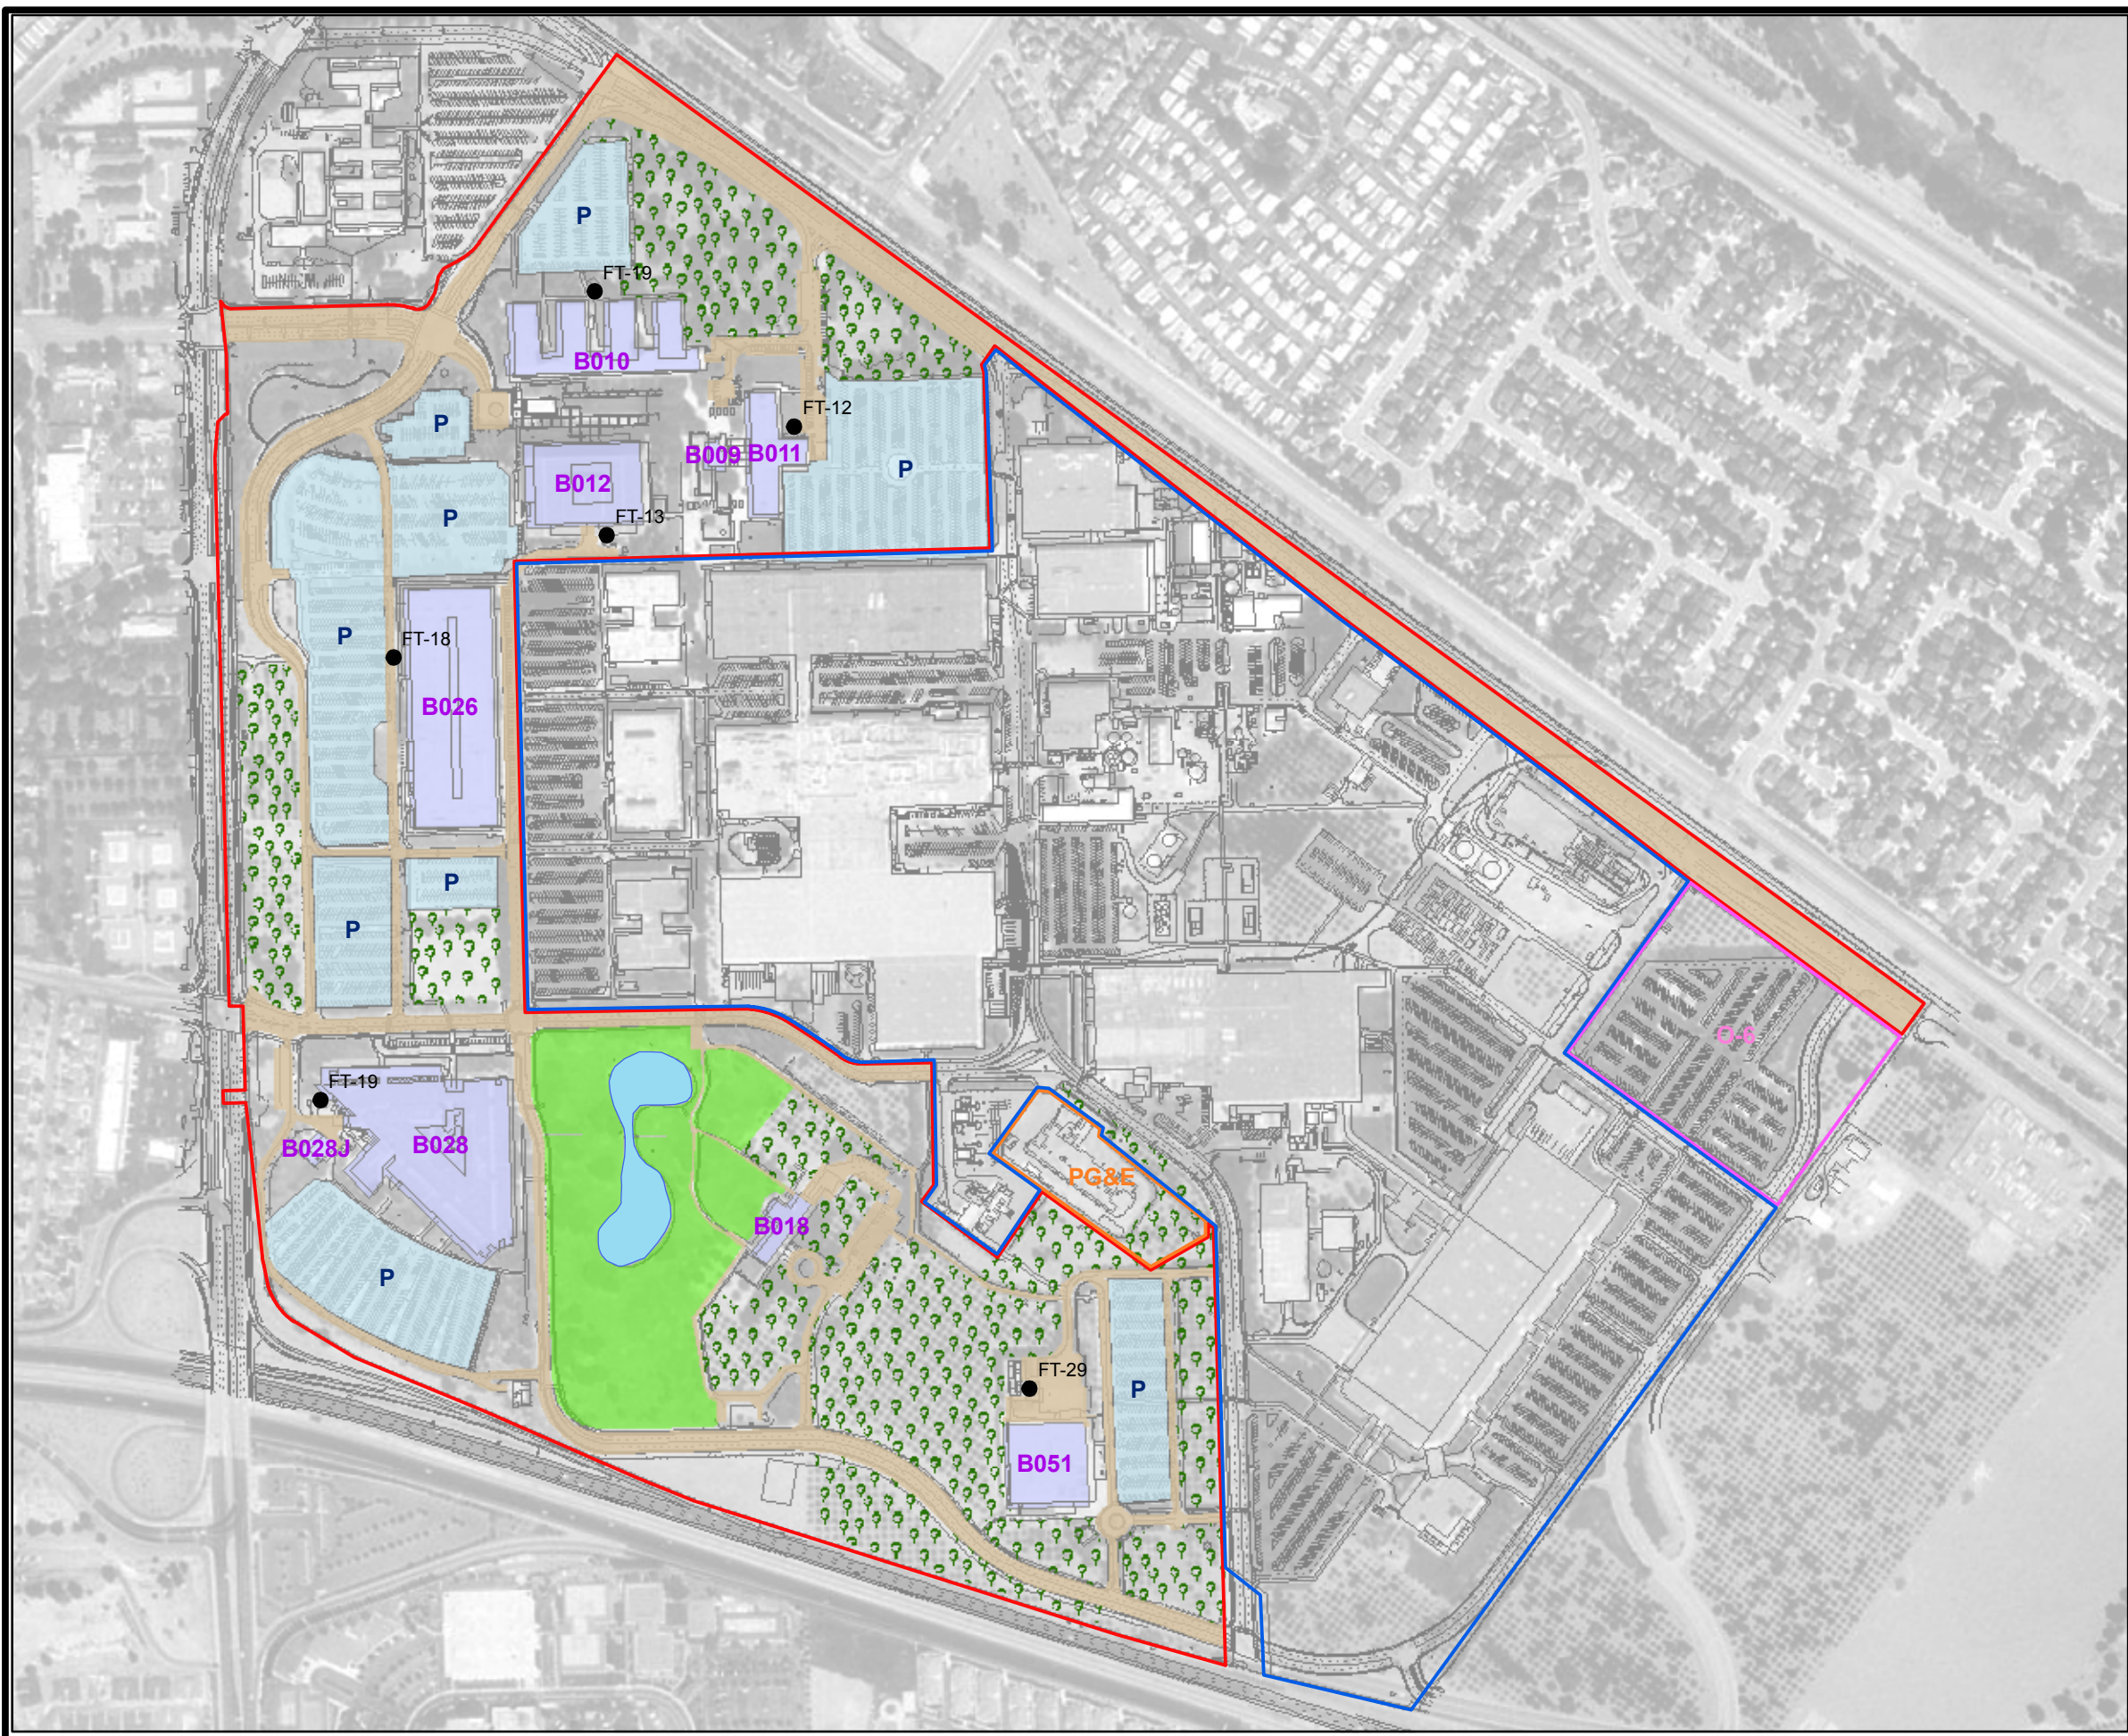
- An environmental engineer should inspect the area surrounding the diesel fuel above-ground storage tank (AST) (Fuel Tank 11 [FT-11]) located north of Building 010 and associated piping once they have been removed. If any indications of leaking are present (cracking, visual staining), soil sampling should be conducted.
- An environmental engineer should inspect the area surrounding the diesel fuel AST (FT-12) and associated piping adjacent to Building 011 once they have been removed. If any indications of leaking are present (cracking, visual staining), soil sampling should be conducted.
- An environmental engineer should inspect the area surrounding the diesel fuel AST (FT-13) located outside Building 012 and associated piping once they have been removed. If any indications of leaking are present (cracking, visual staining), soil sampling should be conducted.

- An environmental engineer should inspect the area surrounding the diesel fuel AST (FT-18) and associated piping located west of Building 026 once they have been removed. If any indications of leaking are present (cracking, visual staining), soil sampling should be conducted.
- An environmental engineer should inspect the area surrounding the diesel fuel AST (FT-19) located near the northwestern corner of Building 028 and associated piping once they have been removed. If any indications of leaking are present (cracking, visual staining), soil sampling should be conducted.
- An environmental engineer should inspect the area surrounding the diesel fuel AST (FT-29) located within the fenced area for the Building 051 cooling tower and associated piping once they have been removed. If any indications of leaking are present (cracking, visual staining), soil sampling should be conducted.
